CASE STUDY

Conversion of Solar-Powered Rectangular Rapid Flash Beacon (RRFB) to a Solar-Powered HAWK Signal or Pedestrian Hybrid Beacon (PHB)

Case Study Background

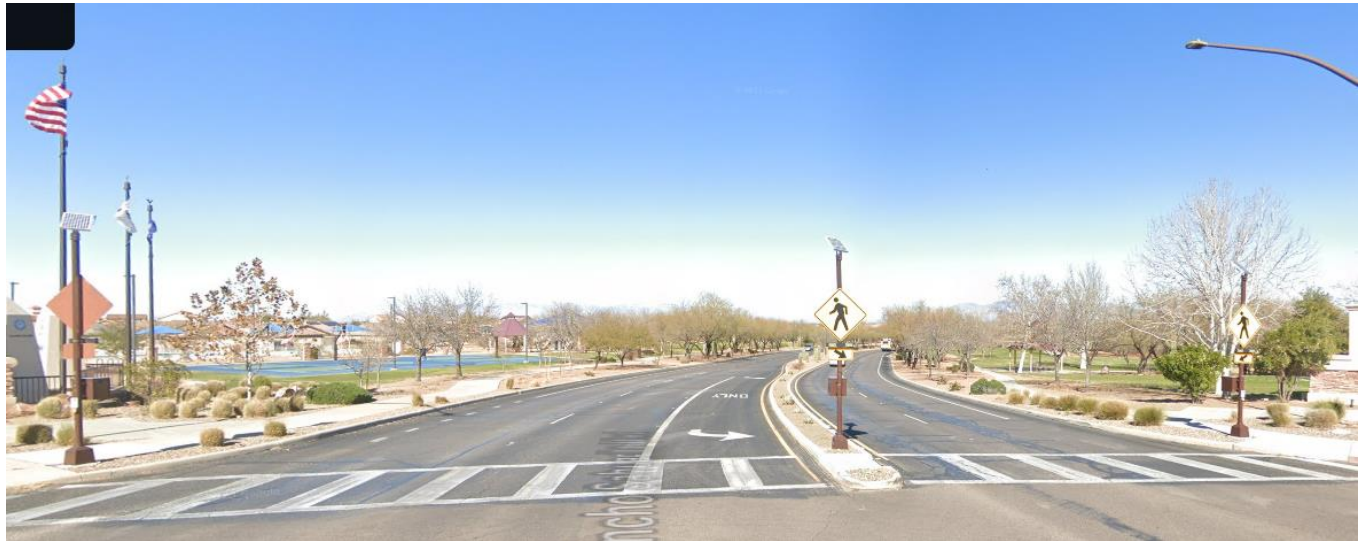
BEFORE: RRFB Crossing installation (cost \$15,558 in 2024 dollars) excluding poles and foundations

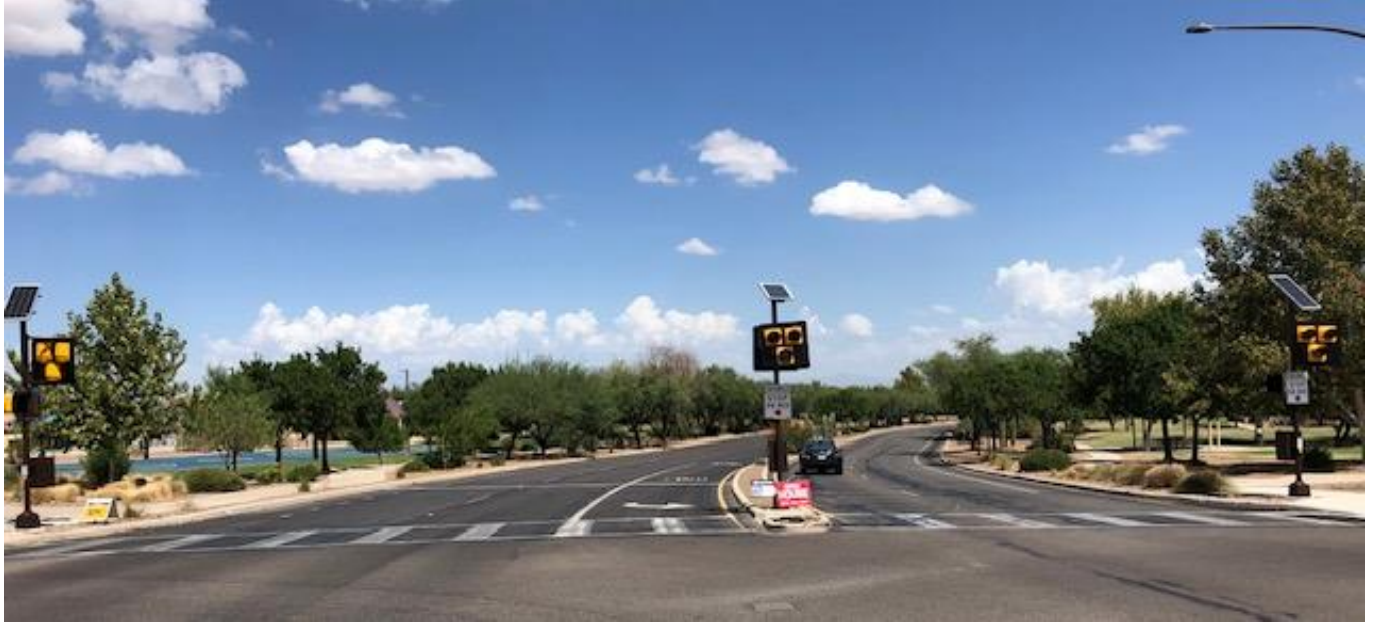
AFTER: Conversion to a HAWK Crossing (cost \$29,270 in 2024 dollars) using existing poles and foundations from original RRFB installation

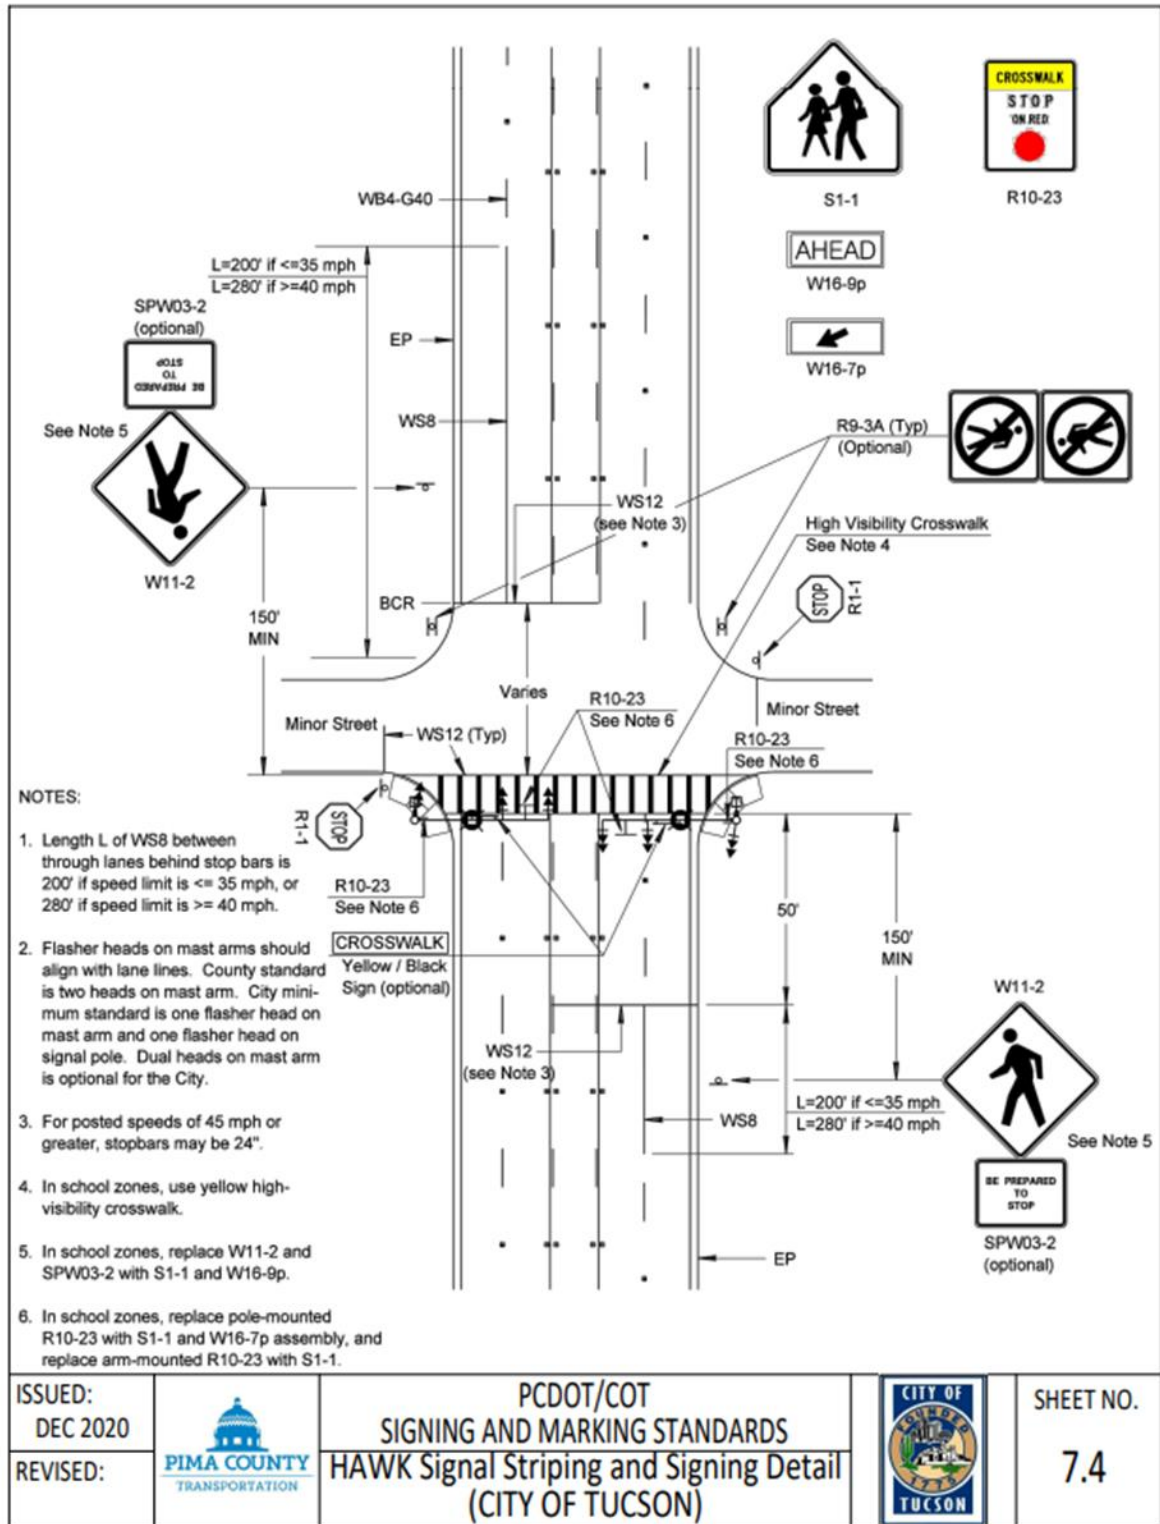
Appendix Figure A: Notes 2,4,5,6 are not applicable. Lighting is under the responsibility of another agency other than the town

- Attached are the Pima County/ City of Tucson Guidelines, Appendix Figure A,
- The drivers approaching the new HAWK beacon were observed to be stopping properly without signs at the new stop bars. Appendix Photo D. (If the town considers R1-5b STOP HERE FOR PEDESTRIANS (Symbolic) on both the median and side of the road due to the horizontal and vertical elements of the road, it is critical to ensure the placement of the signs do not block the view of the curb side HAWK beacons as a vehicle approaches in the curb lane.)

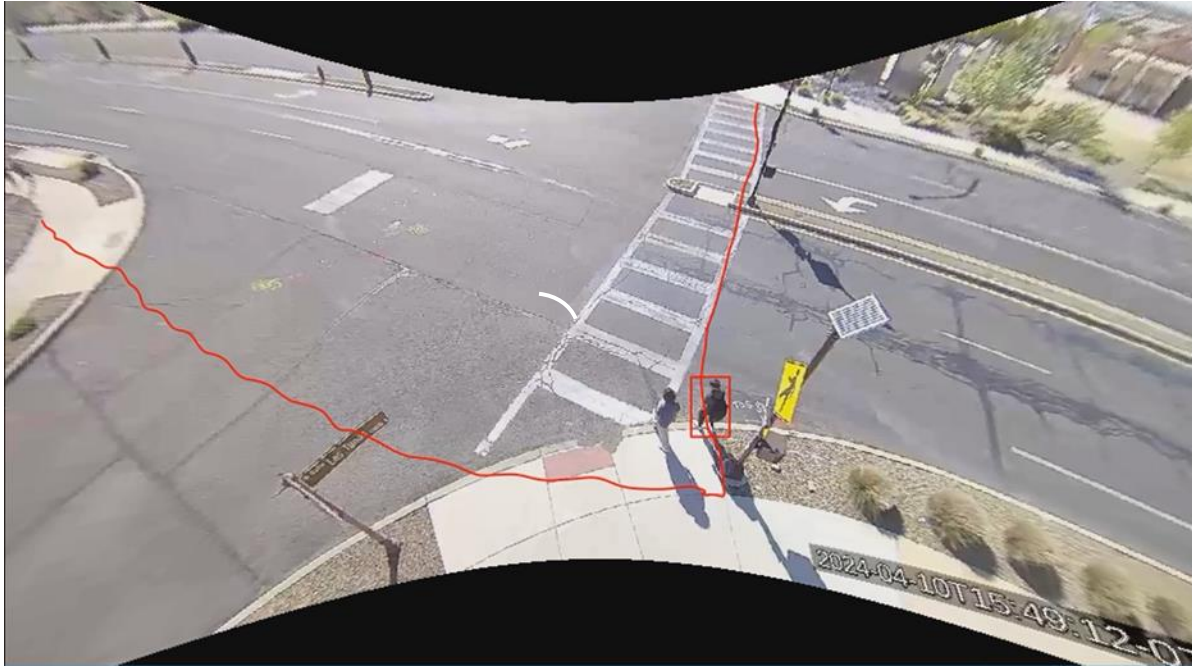
Appendix Photo B1: Children activate YELLOW flashers

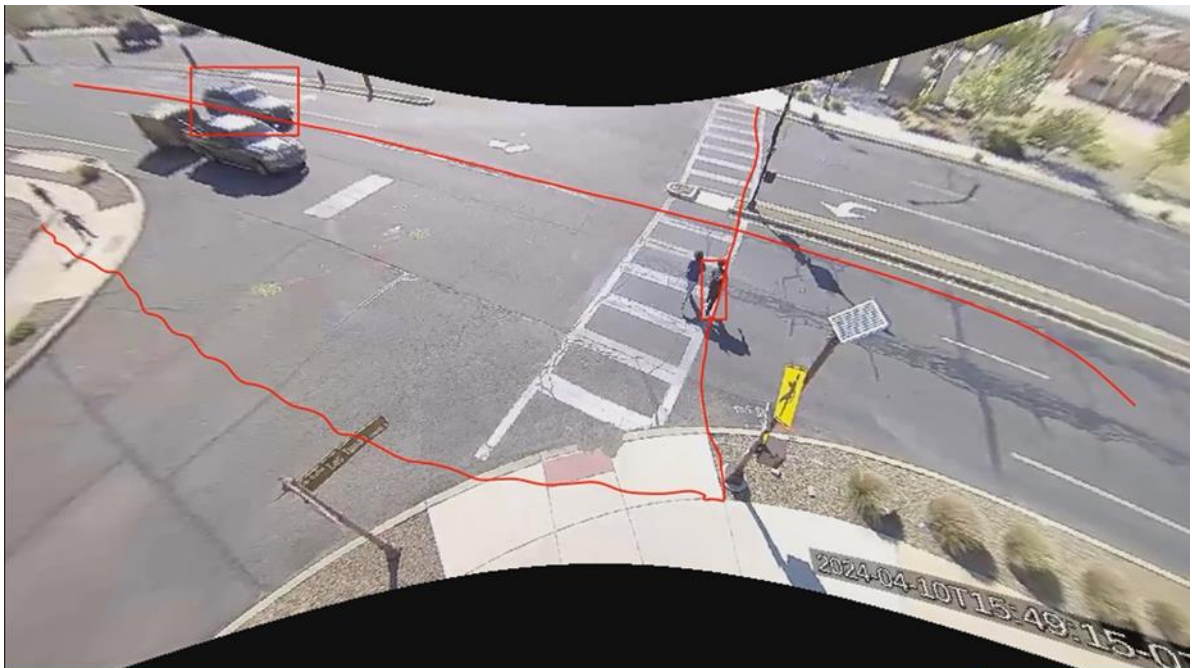
Appendix Photo B2: Children begin crossing. The curb lane driver sees and yields to children on the crosswalk. The median driver seems to fail to see the crossing children and proceeds to pass the yielding vehicle illegally and then begins hard braking so as to not strike the children.

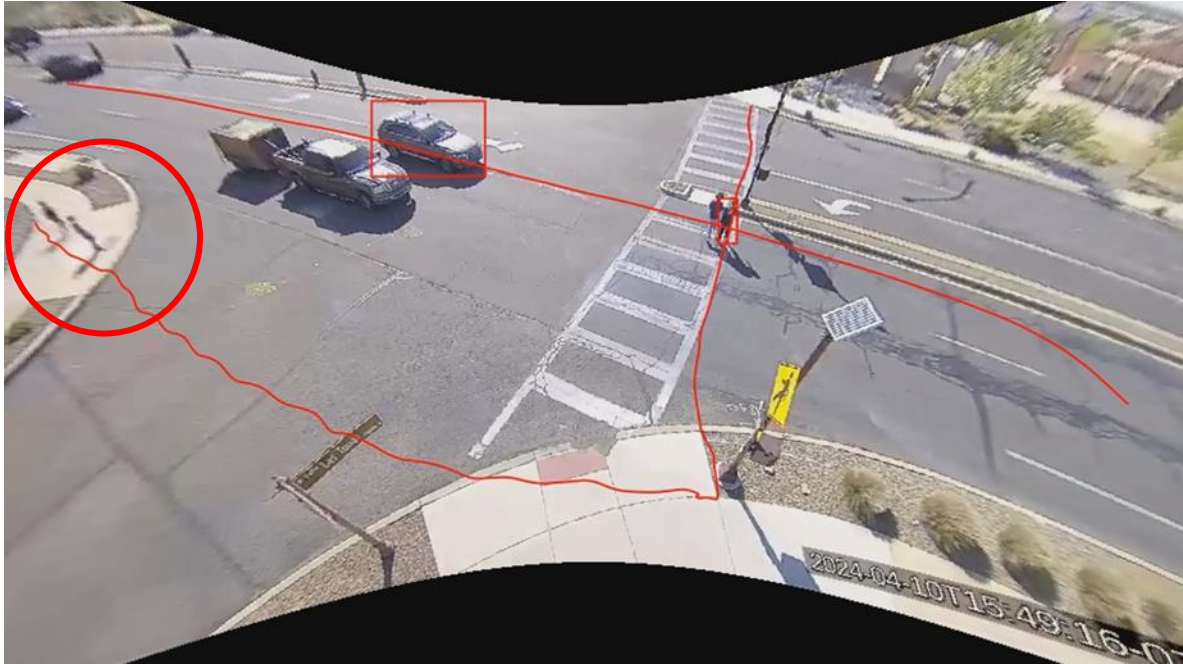
Appendix Photo B3: Median driver sees children and attempts to stop immediately. Children run to the median to get out of the street and to a point of greater safety. Notice the children in the southeast corner seeing and most likely hearing the traffic commotion and looking toward the vehicles

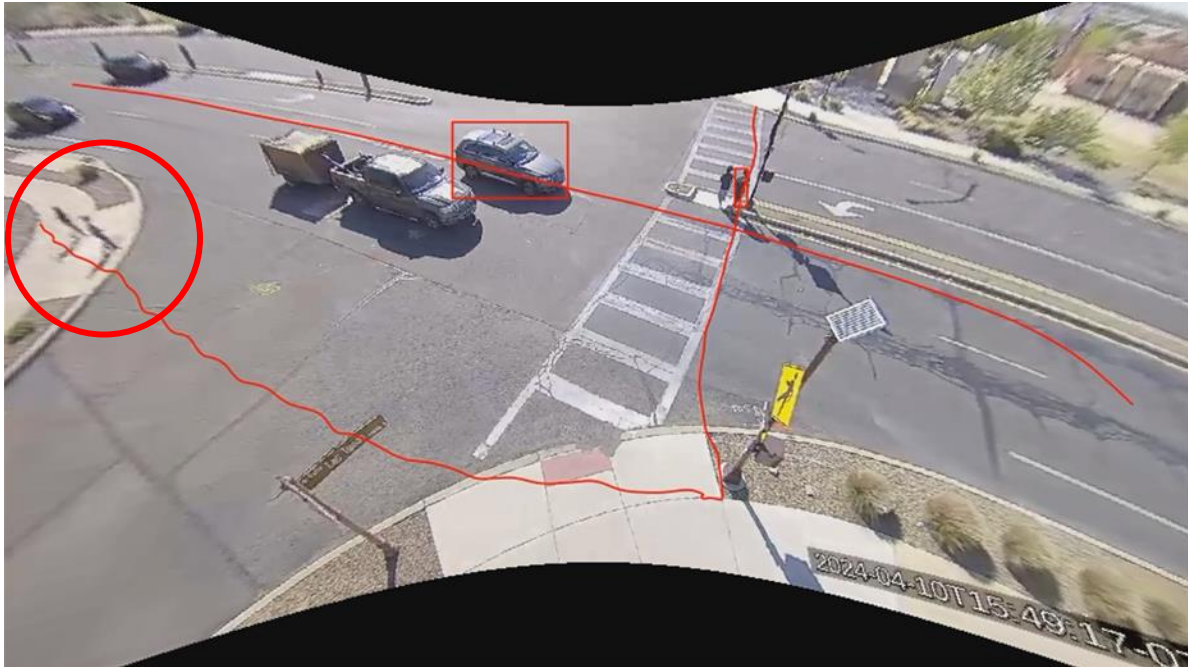
Appendix Photo B4: Crossing children leave island and run across the other half of the crossing to get away. The median lane driver is still trying to stop. Children on the southeast corner, realizing the danger, react to the situation and one friend begins to pull the other back from the curb.

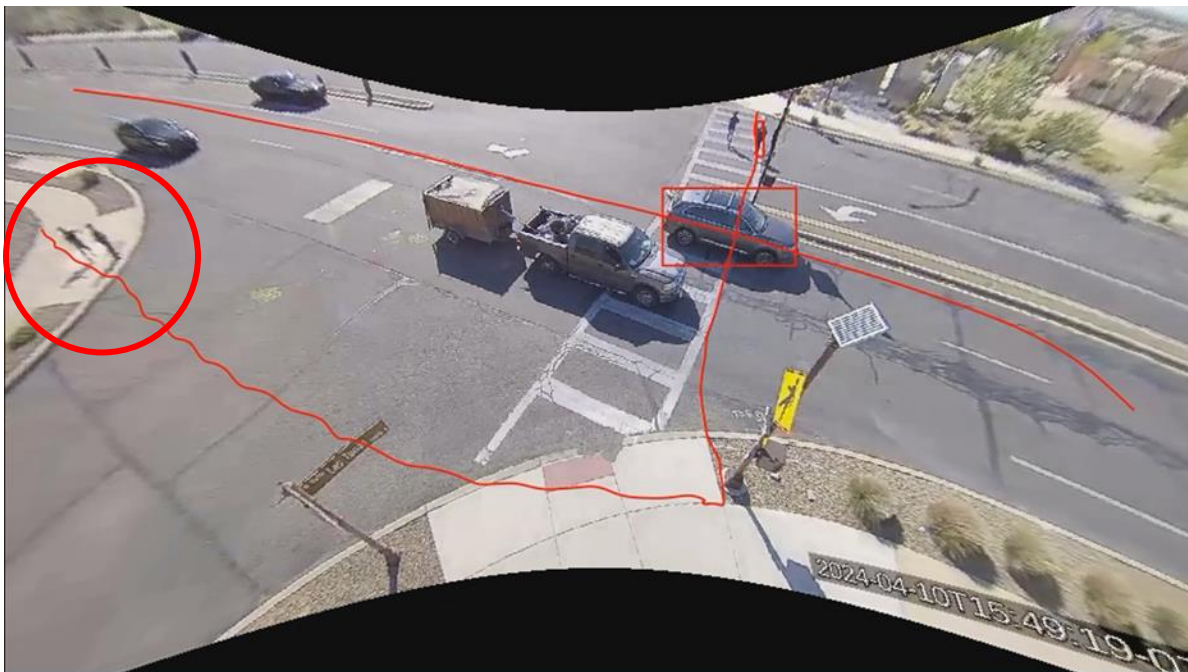
Appendix Photo B5: Crossing children run to the far curb to safety. The median driver is not able to come to a complete stop and passes through the crosswalk. The concerned child friend on the southeast curb was still holding on to his friend pulling him back from traffic.

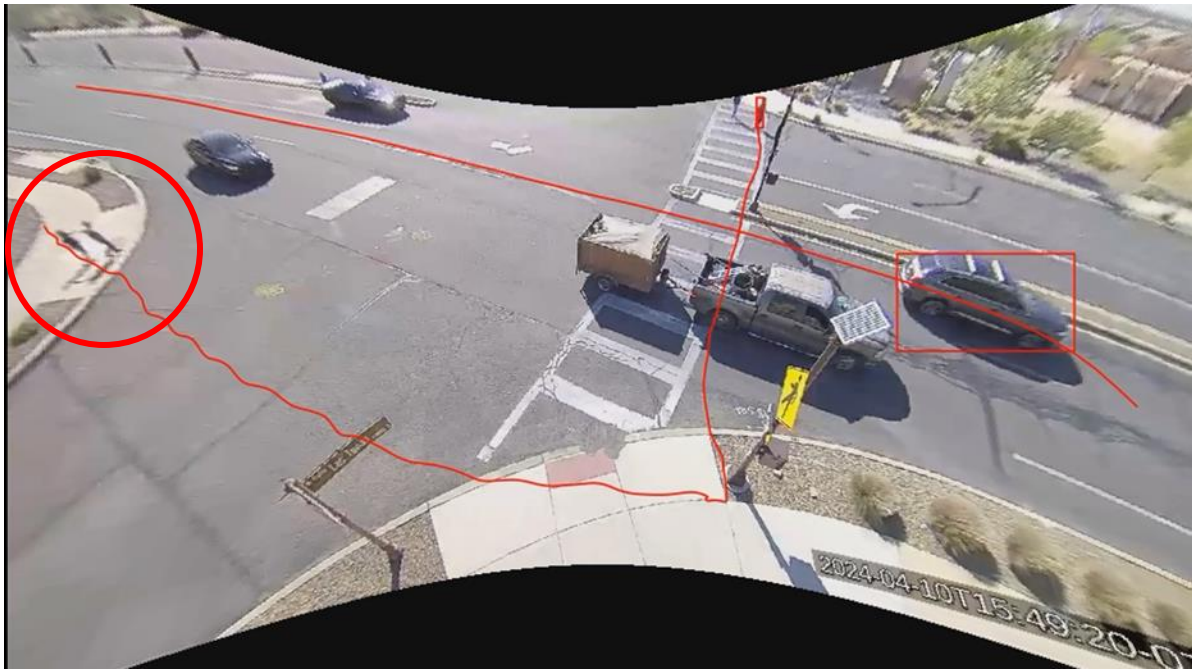
Appendix Photo B6: The median driver never fully stops. Crossing children are now completely safe on the far side of the street. The traffic is moving through or past the crosswalk and the friend is still holding onto the other's shirt still continuing to pull him back from the street

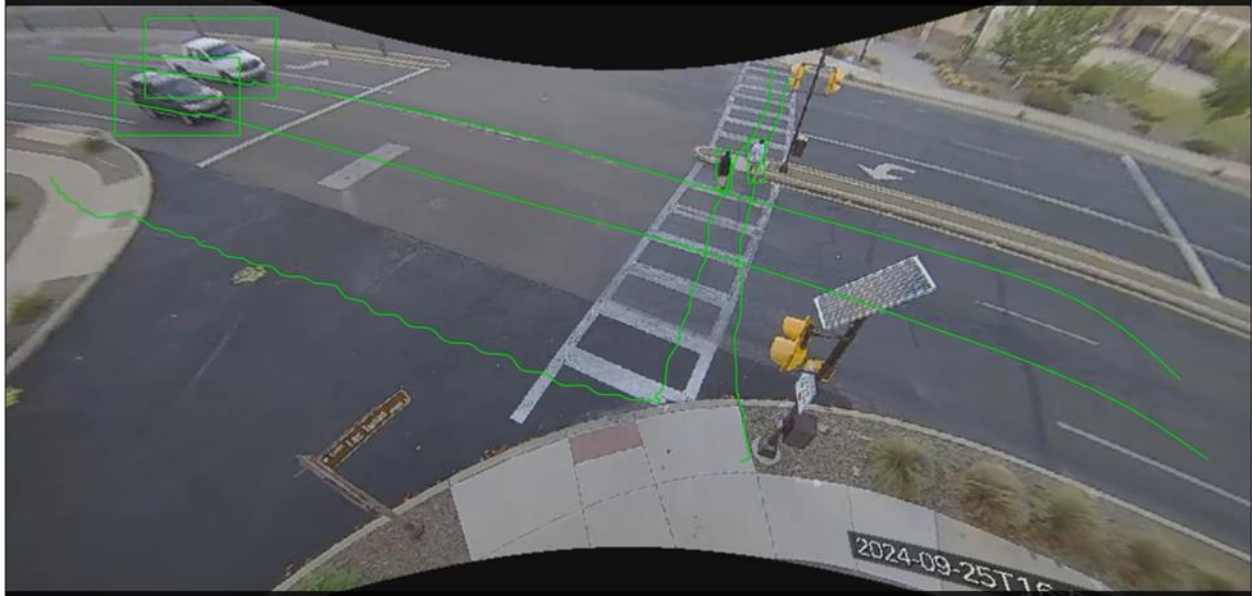
Appendix Photo C1: Both drivers are shown a HAWK Beacon solid RED indication and stop properly at the stop bar, allowing the children to cross in relative safety. This positive driver behavior is quite evident when compared to the RRFB Appendix yield B1 through 5 which shows a failure to yield to the crossing children and the driver in the median lane shows the most reluctant yielding and dangerous conflict behavior.

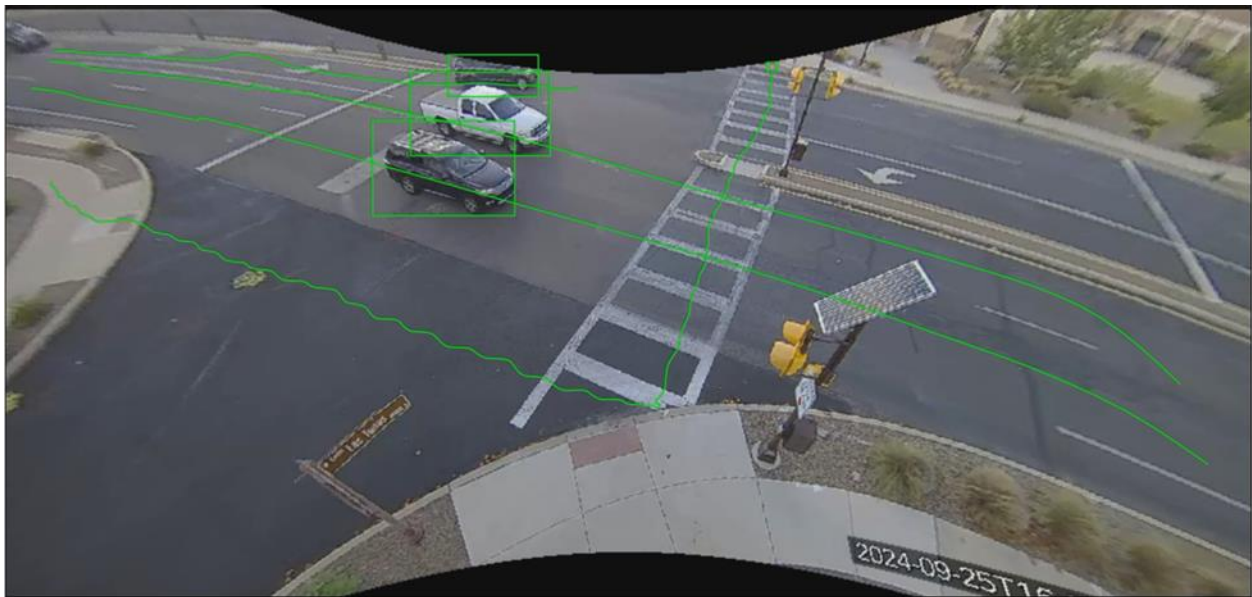
Appendix Photo C2: The children have now completed their crossing, and the drivers now are proceeding through the crosswalk during the flashing RED indication when it is safe to proceed. Further it is critical to note that there were no conflicts, or “close calls” noted during the video study.

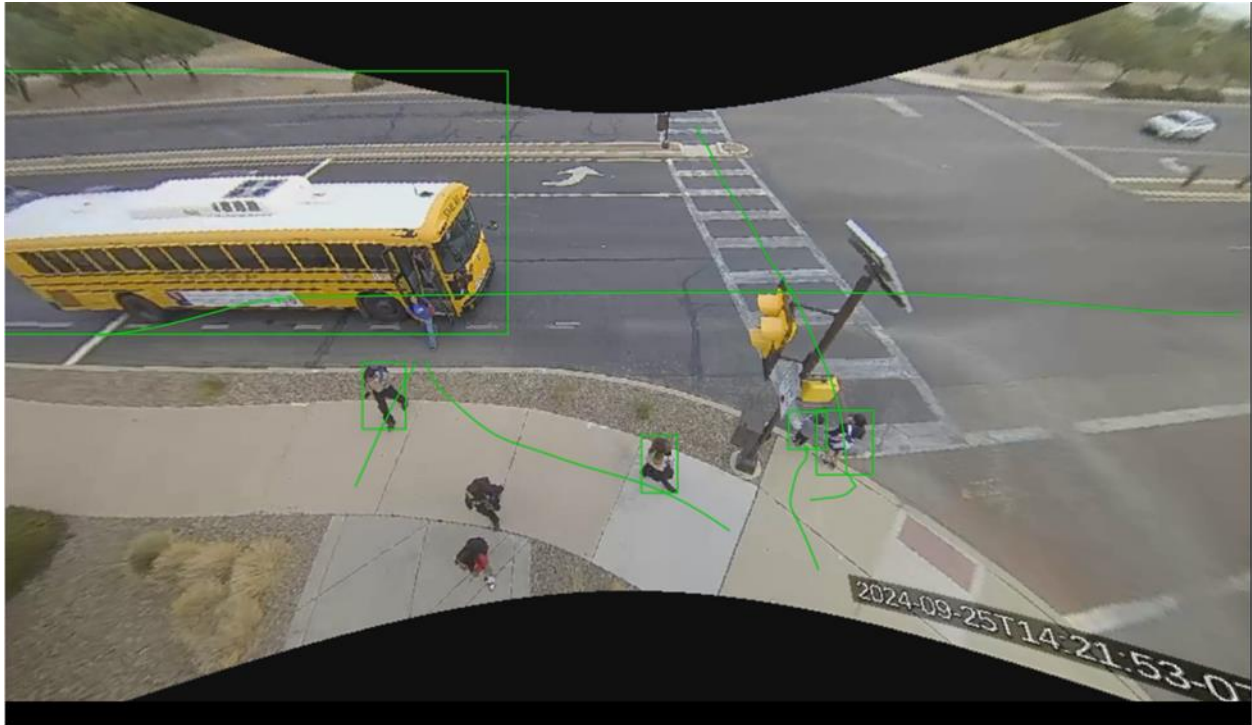
Appendix Photo C3: School Bus operations are greatly facilitated with the new HAWK crossing operation over the RRFB. The children alight/disembark and cross the street to or from their homes in greater security. The school bus lights are RED as well as the HAWK's RED lights, but as the children cross with the flashing RED lights on the school bus they do not provide protection while crossing the other half of the divided roadway. Since the roadway is divided, only the HAWK crossing beacon protects the crossing children all the way across the road. As can be seen in photos C4 and C5

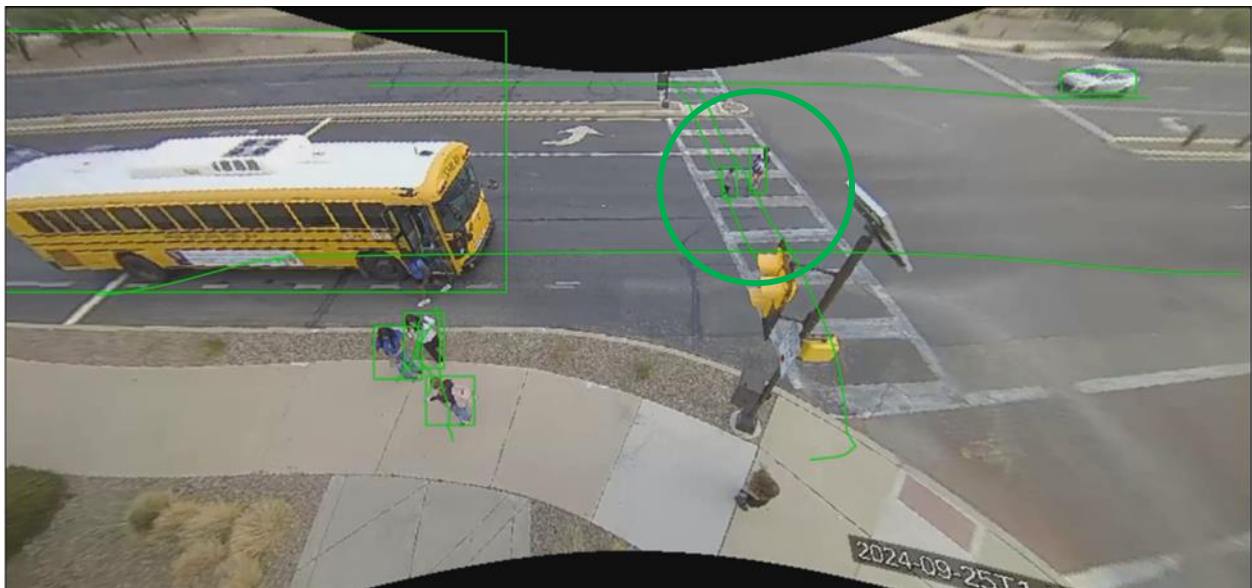
Appendix Photo C4: The school bus lights are on. The west to south traffic stops at the back of the bus. However, since the road is divided, the north to east traffic is not required to stop for the bus's RED flasher. (see the white vehicle still waiting for the crossing children).

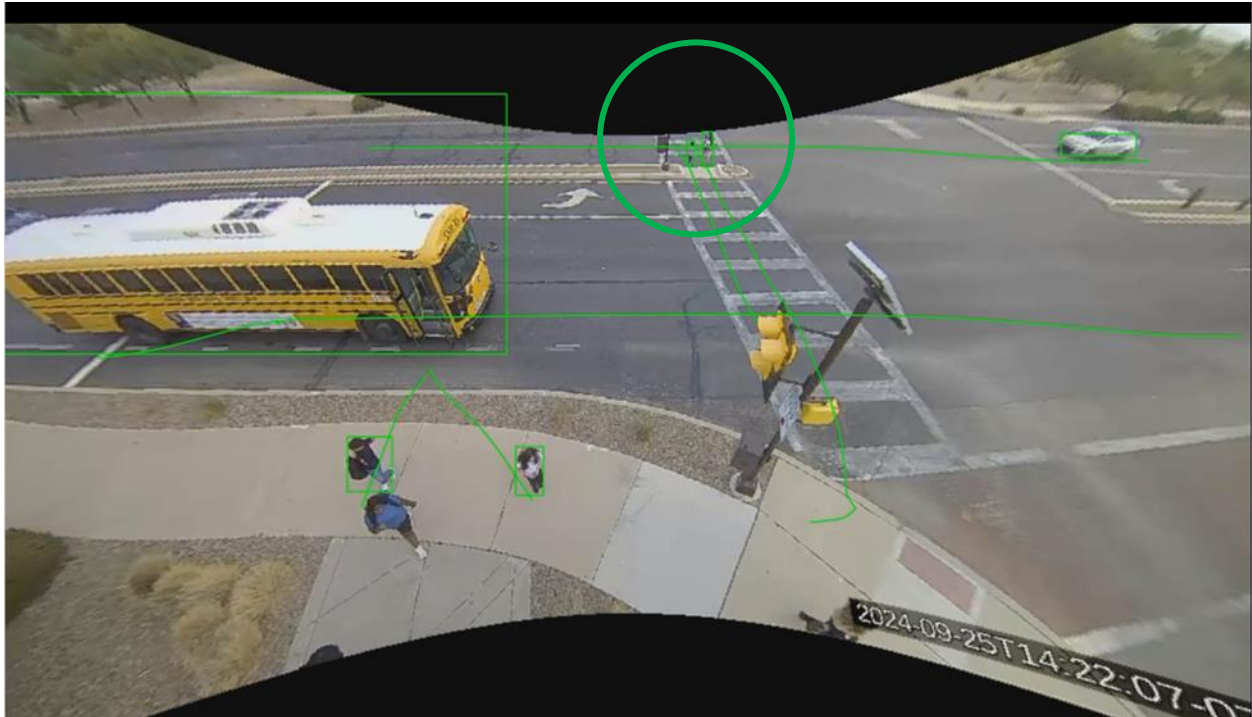
Appendix Photo C5: As the children prepare to cross the second half of the roadway, they are further protected by the HAWK RED beacon as they prepare to cross the second half of the street, since the state school bus law does not require a stop for the school bus RED lights on a divided highway under this condition. (note the white vehicle is still waiting)

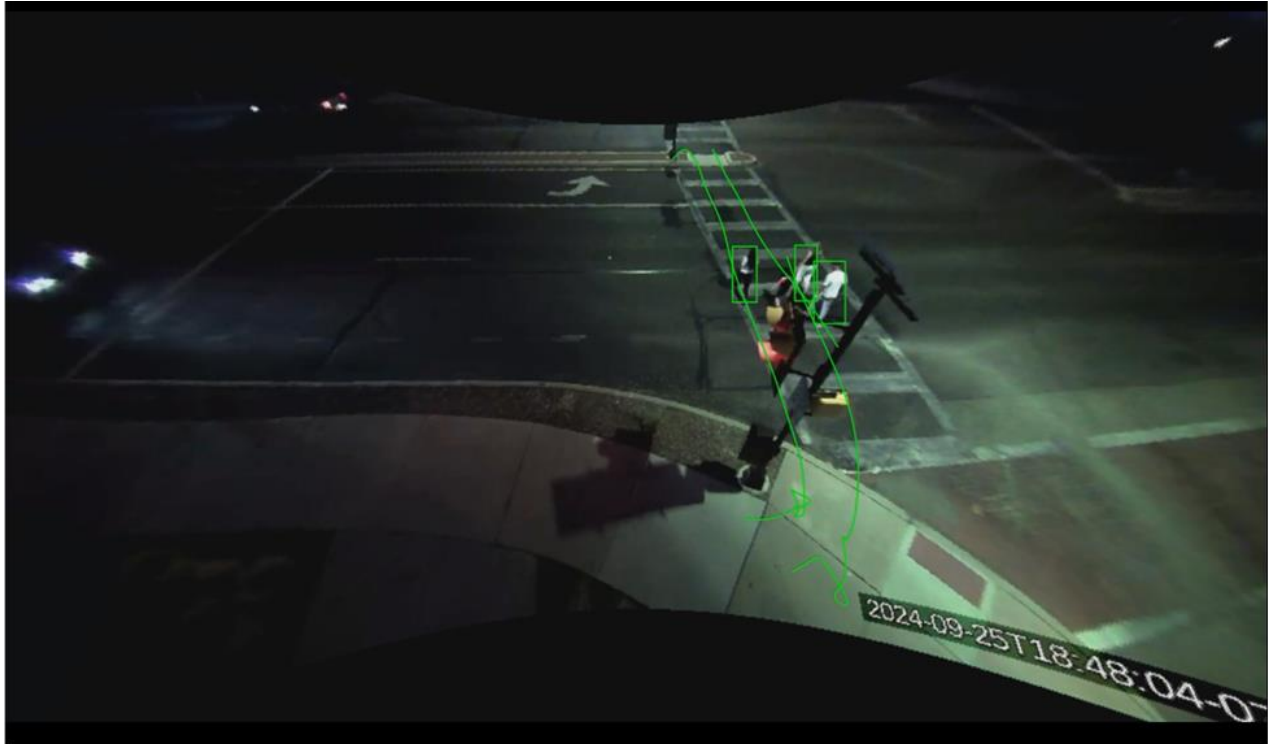
- d) Roadway Lighting is present, seems adequate (owned by another authority), see Appendix Photos C6, 7
- e) Traffic conditions have changed significantly since the installation of the RRFB constituting the need for other higher level traffic control devices to be considered
- f) Speed limit signs are installed at frequent intervals and visible. However, drivers were still observed traveling above the posted 30 mph speed limit, though not to a level that would meet enforcement policy/court levels, but could be to a level that may begin to reach the upper limit of the horizontal and vertical curve design levels

Appendix Photo C6: Drivers wait at the stop bars during the RED indication. Lighting is adequate

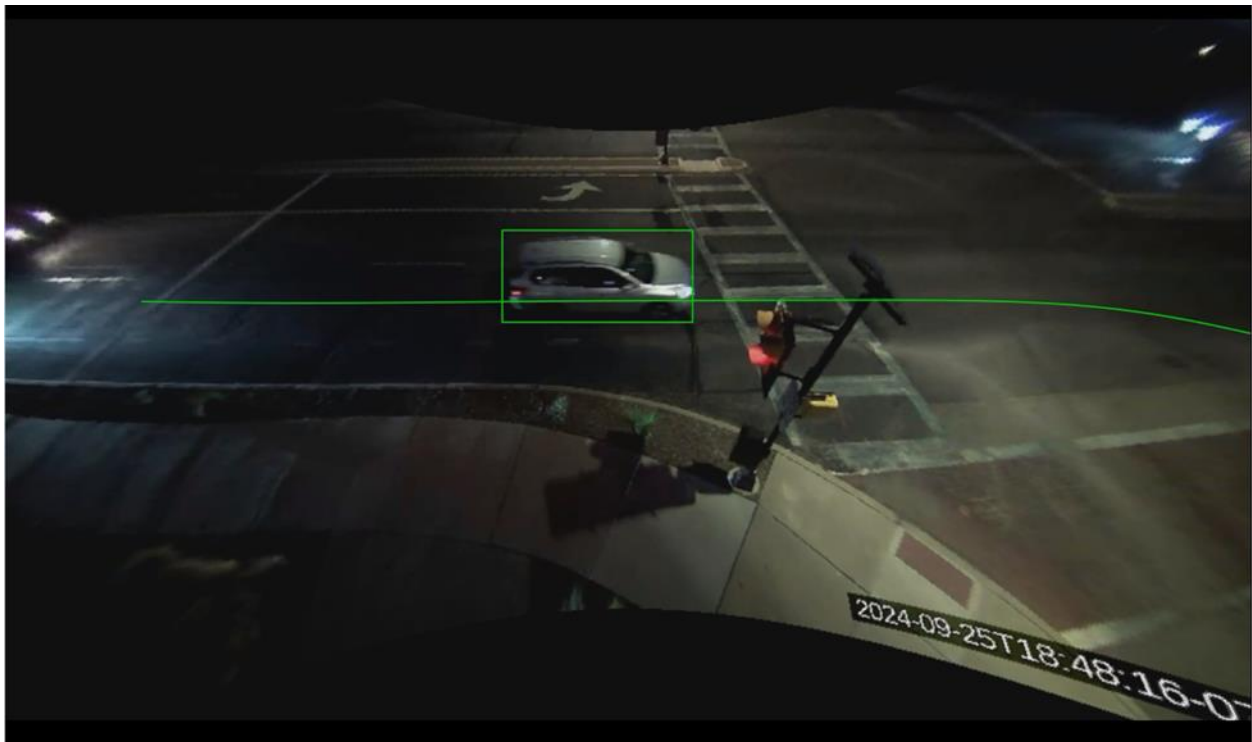
Appendix Photo C7: Drivers pass through the crossing during the FLASHING RED indication after the crossing family has moved to a position not in conflict with the vehicle(s).

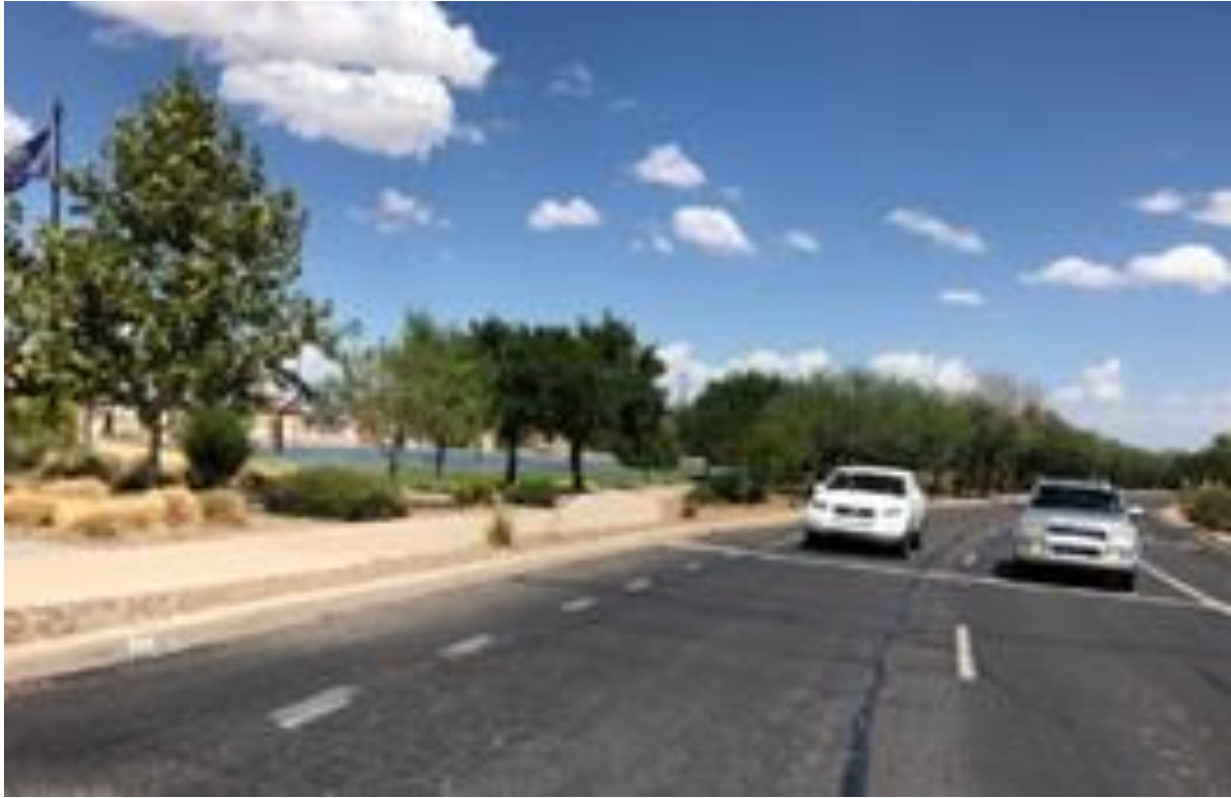
Appendix Photo D: Drivers wait at the proper location without the need for signing
